US Army Corps
of Engineers

Construction Engineering
Research Laboratory

CERL Technical Report 99/54
June 1999

Potable Water Pipe Inspection at Westover Air Reserve Base, Chicopee, MA

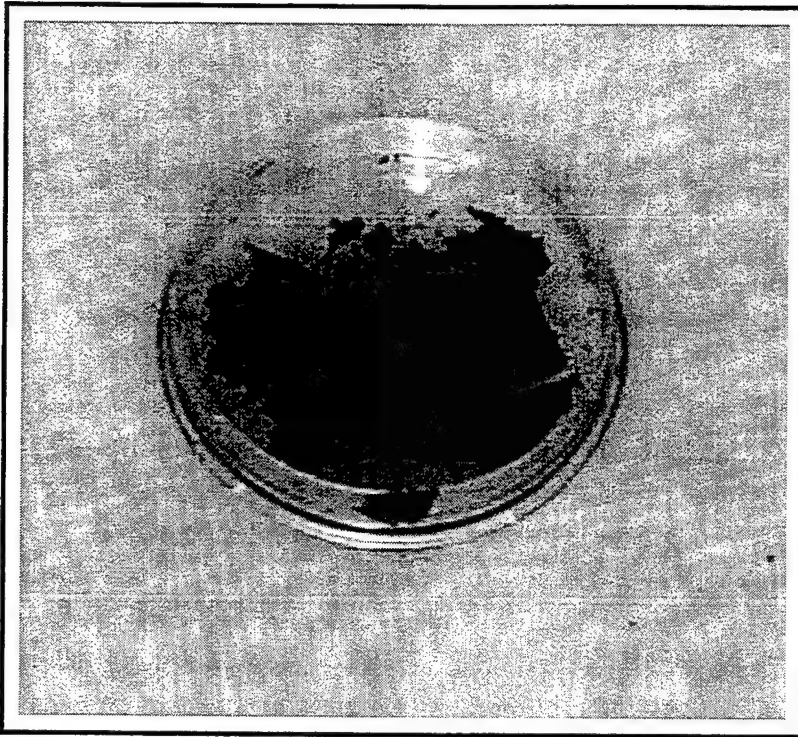
CERL investigators examined the coating materials in the petrie dishes. The material in the first petrie dish was soft and pliable, and appeared to be partially cured lining material (Figure 1). It was the same thickness and color as the inner lining material of the pipe previously examined. The several pieces stuck together and had to be pulled apart for examination. The material in the second petrie dish appeared to be fully cured (Figure 2). It was black in color with a thin, smooth layer of cementitious material on one side. A small portion of the inner coating material was removed for microscopic evaluation by chipping it off with a chisel and hammer. Examination of the coating pieces removed showed a much thicker layer of cementitious material, and a much rougher cementitious surface than the samples in the petrie dish.

Figure 1. Uncured coating recovered following flushing.

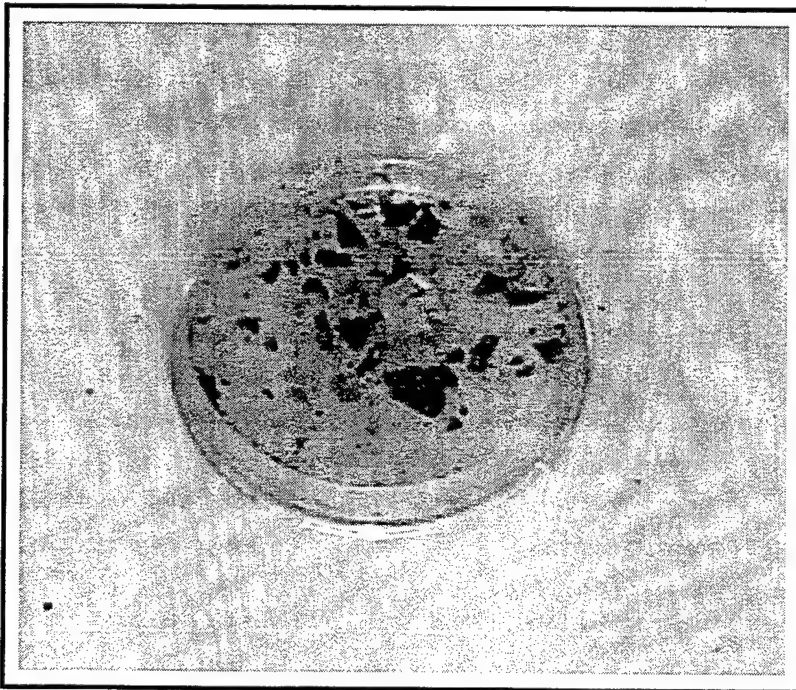
Figure 2. Cured coating recovered following flushing.

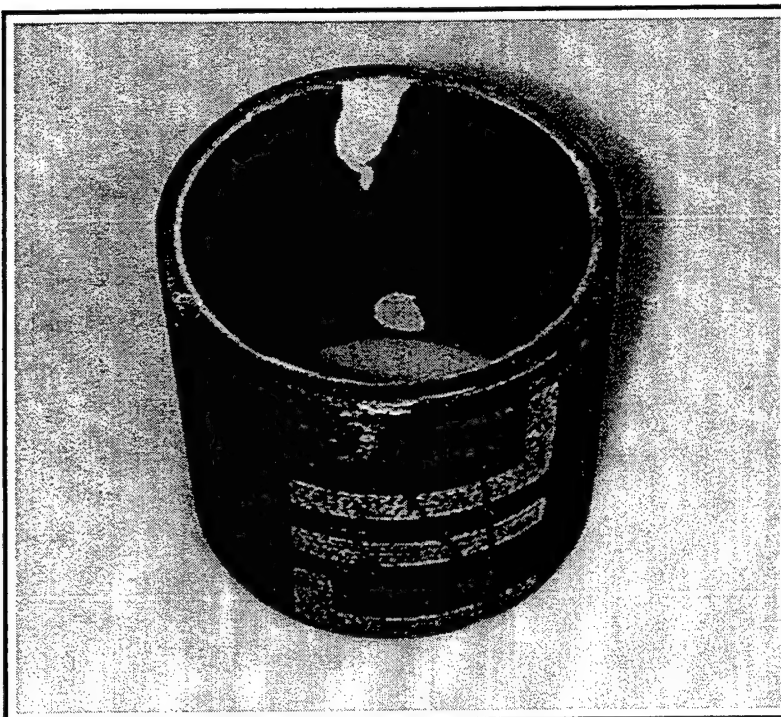
To evaluate the susceptibility of damage to the pipe lining due to sudden impact, the outside of the pipe was struck with a sledgehammer. A small portion of the inner liner popped off at the point of impact. The piece that popped off had the same thin coat of cementitious material on it as was seen on the sample in the second petrie dish. The cementitious material remaining on the inside of the pipe appeared unaffected (Figure 3). This indicates that sudden impact will cause the inner asphalt-epoxy liner to separate, leaving bare cement. The asphalt epoxy inner lining material from the pipe provided to CERL and the two different materials provided to CERL in the petrie dishes were also examined using scanning electron microscope elemental analysis. This analysis confirmed that all of the materials were also chemically the same.

Figure 3. Inside of pipe sample where struck with sledgehammer.

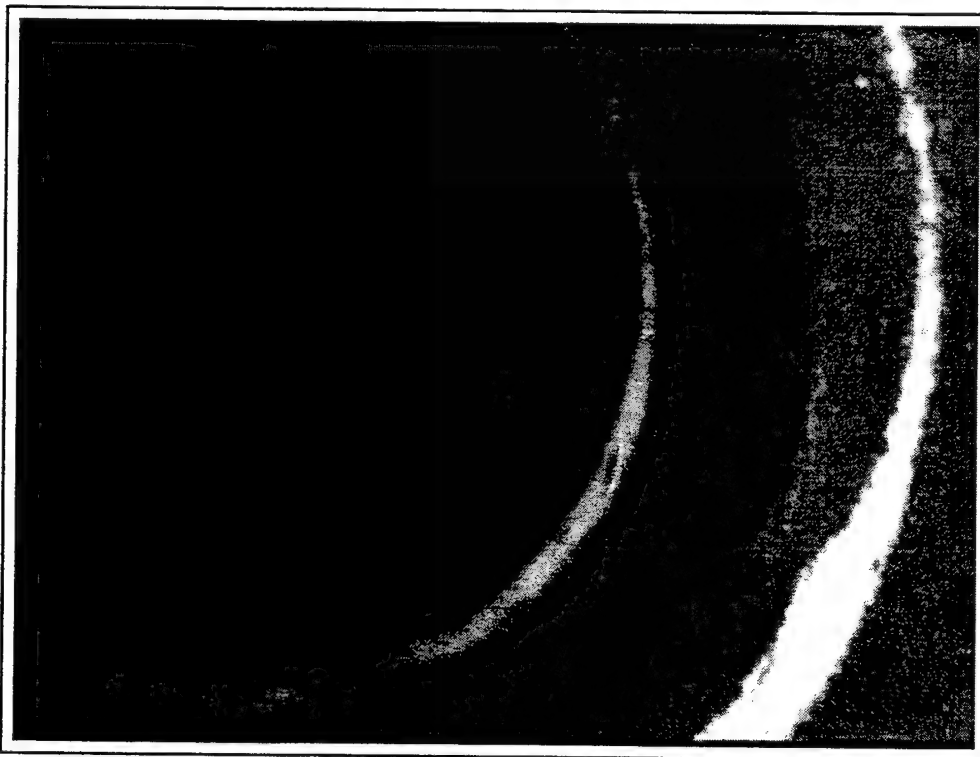
At some locations, sections of pipe contained a series of consecutive rings of coating loss (Figure 7). This occurred in one or two lengths of pipe, from joint to joint, while the other surrounding lengths of pipe are not affected. In some sections, areas of coating loss were intermittent (Figure 8).

Figure 7. Rings of coating loss.

2. Poor quality control was exercised during the installation of the interior lining by the pipe manufacturer. The series of consecutive rings of coating loss in some pipes, and the linear strips of missing coating in others, indicate improper cure of the lining material. Improper cure occurs when manufacturer-specified proportions the epoxy resin and hardener are not maintained during manufacture, or when the components are not adequately mixed prior to application. The observed patterns indicate that it is likely that there was a problem with the mixing during the pipe manufacture process.

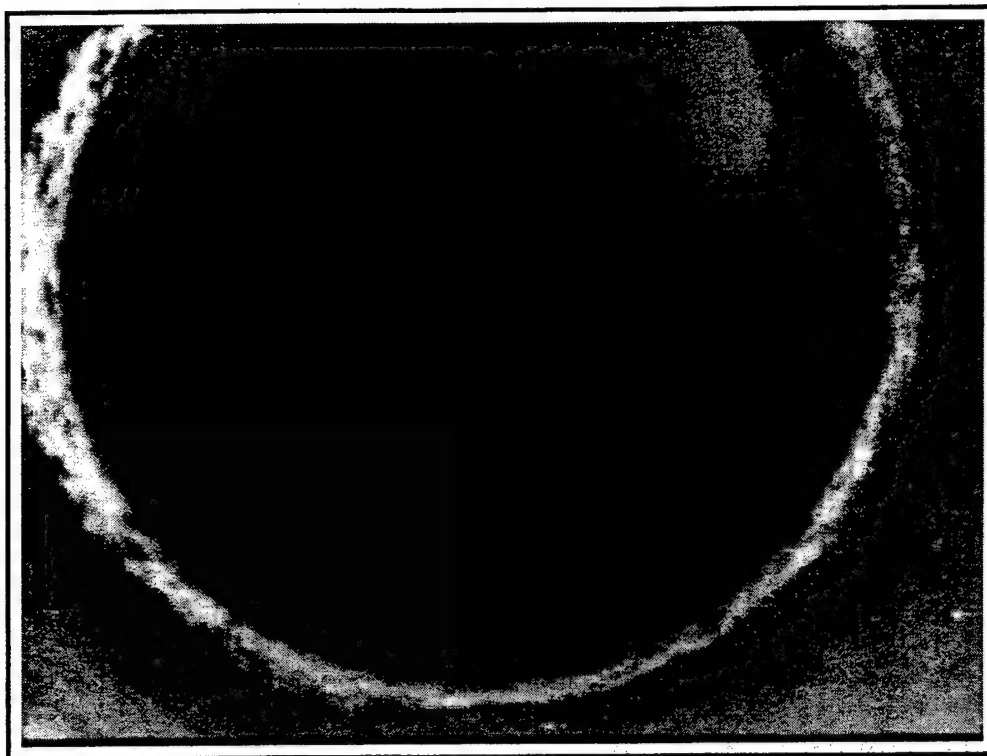
Figure 8. Period losses of coating on seen on the top of photo.

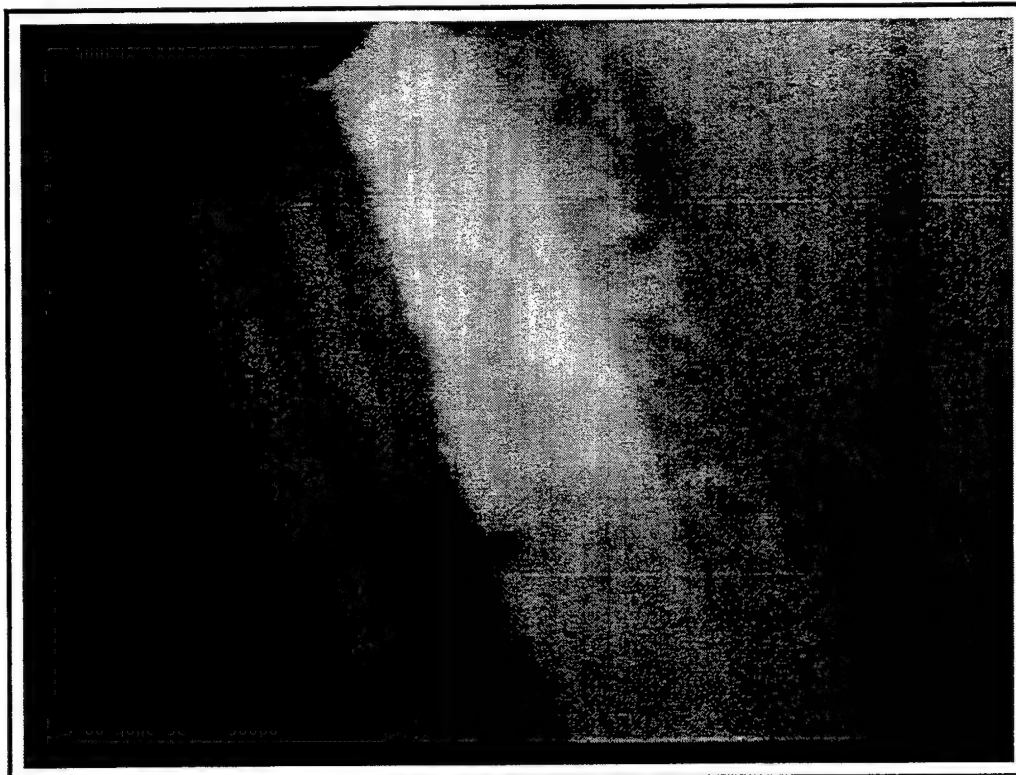
The inspection showed a problem with debris in the mains at some locations. At the corner of Eagle and Hanger, a piece of plastic material lodged in the line would not allow the camera to enter the main (Figures 15 and 16). The plastic was close enough to the entry point that attempts were made to reach in and pull the piece out of the pipe. However the plastic was wedged too tightly to move in any direction. Silt was evident in water lines (Figure 17). A few isolated pieces of gravel were observed in the mains (Figure 18). No dense concentrations of gravel were observed. The system dead ends were dirtier than the rest of the system. A few more pieces of gravel and a more silt were seen there than were seen in the mains.

Figure 15. Plastic wedged in pipe.

3. The flushing and pigging done by Westover ARB was effective in cleaning most of the debris out of the mains. A small quantity of debris still exists in the system. If one large piece of plastic shipping material was found during the Scooter inspection, it is statistically probable that several more were left in the remaining uninspected parts of the system. There is some silt and some gravel in the system, but not a significant amount.
